BARTOLOTT CRYPT FLOOR INVESTIGATIONS AND STABILISATION METHOD STATEMENT

Job Ref: C00410.00

Doc Ref: Method Statement for the removal of the marked stone slabs 'Cangatura' to investigate the underlying floor buildup and subsequent localised stabilisation at the Bartolott Crypt, St. John's Co-Cathedral, St. John's Street, Valletta.

Date: 1st April 2024

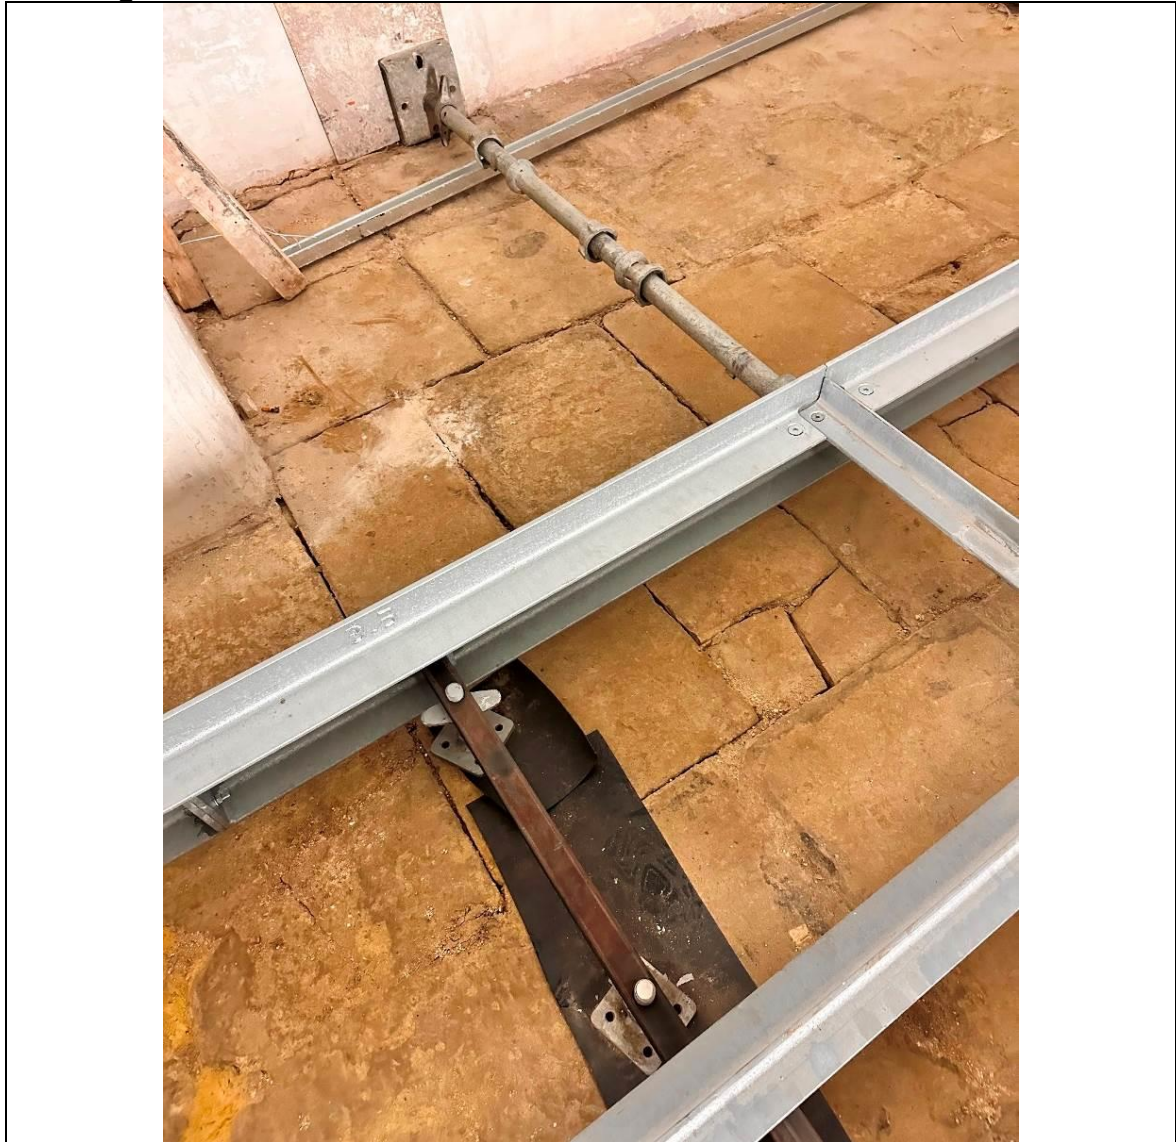
Introduction Throughout the current ongoing works within the Crypt, it has been noticed that several stone slabs 'cangatura' have subsided in localised areas when subjected to normal service loading. In view of this, the following precautionary investigations and works are being proposed:

Photo 01-Localised Area with subsided floor

It is being proposed to stabilise the stone slabs ‘cangatura’ wherever a suitable substrate such as rock or walls are exposed throughout Phases 01-04. Depending on the thickness required, stabilisation works will consist of inserting a lime sand mortar or grout or a stone ‘baxxa’ in between the underlying rock/wall/arch substrate and the reinstated stone slabs cangatura.

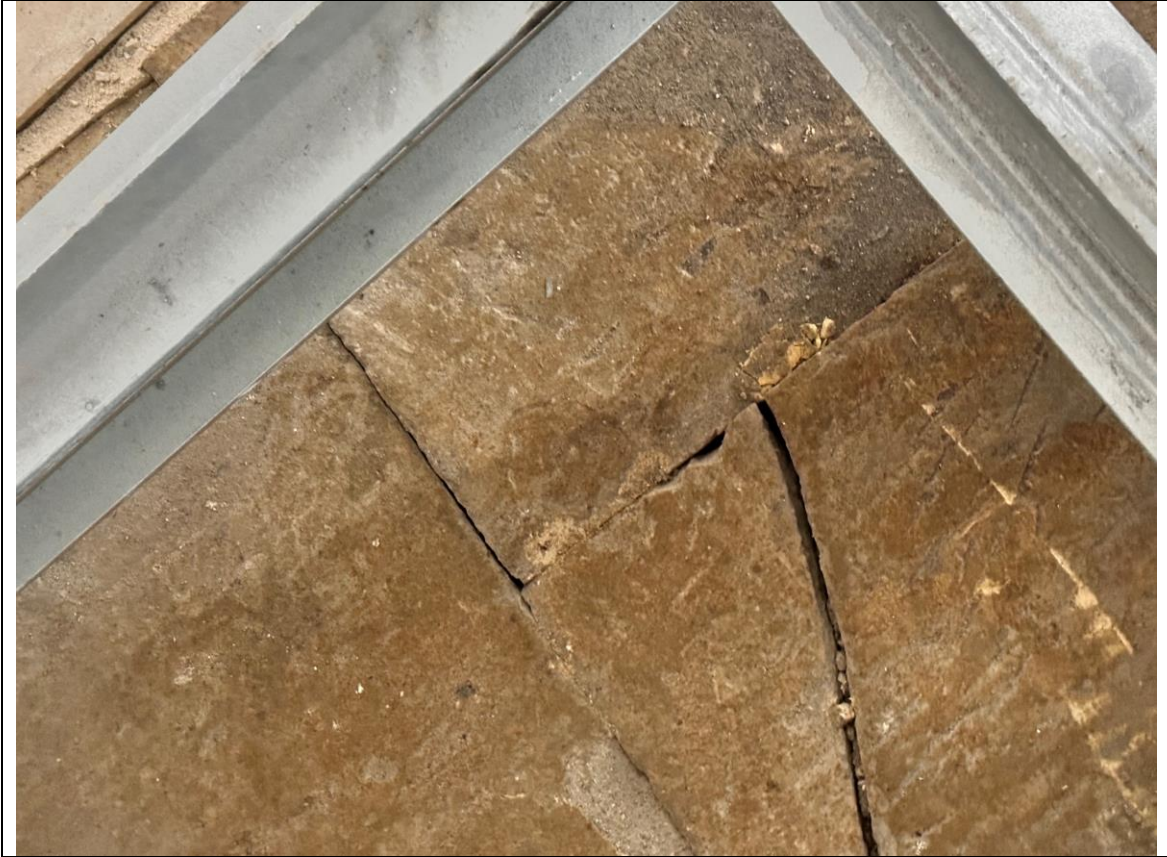
Photo 02-Localised Area with subsided floor

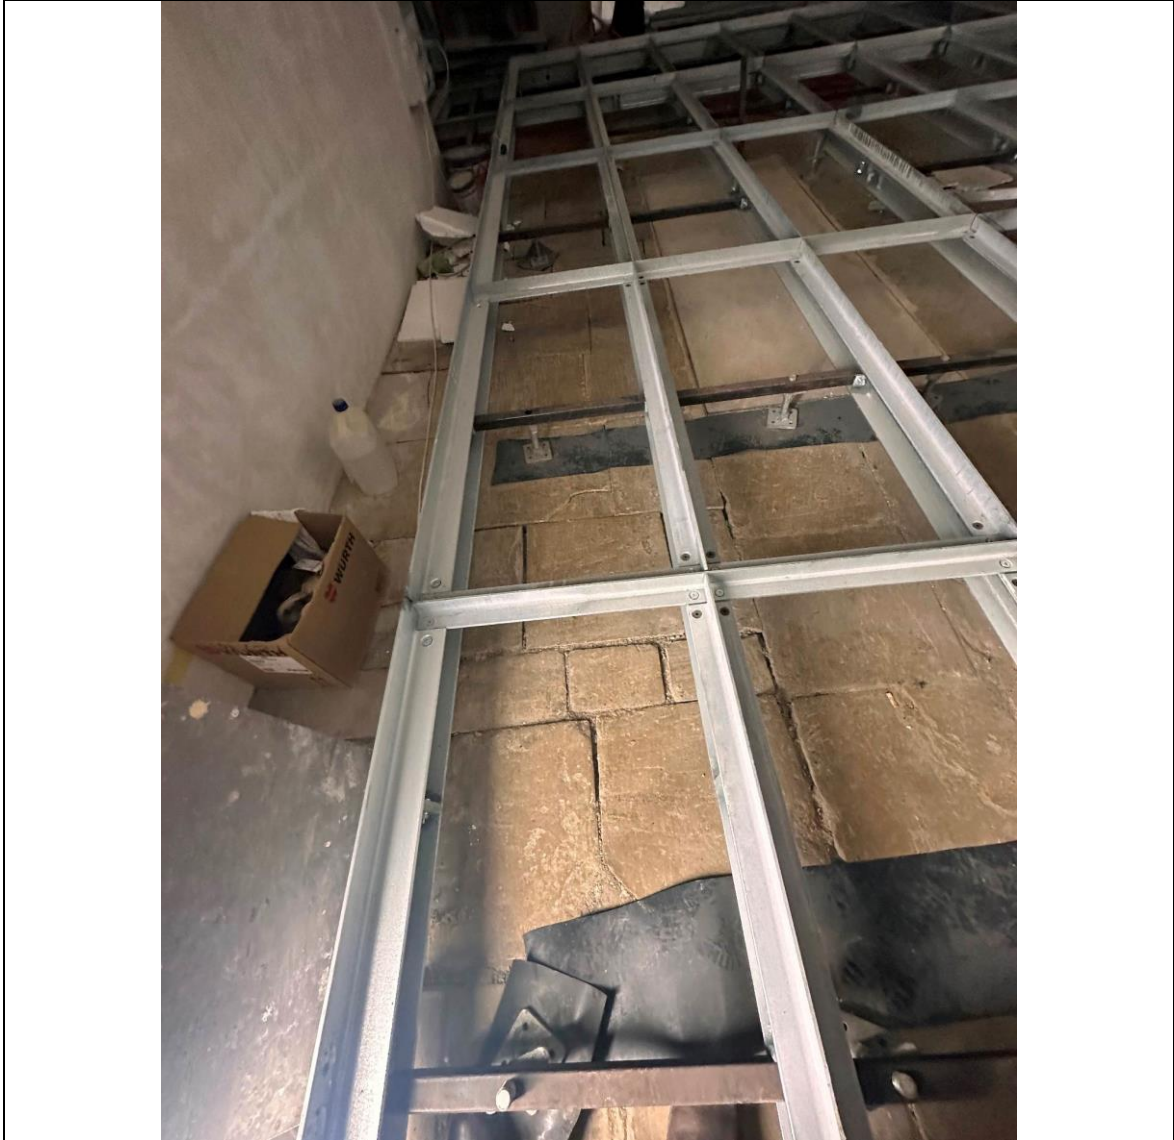
Photo 03-Localised Area with subsided floor

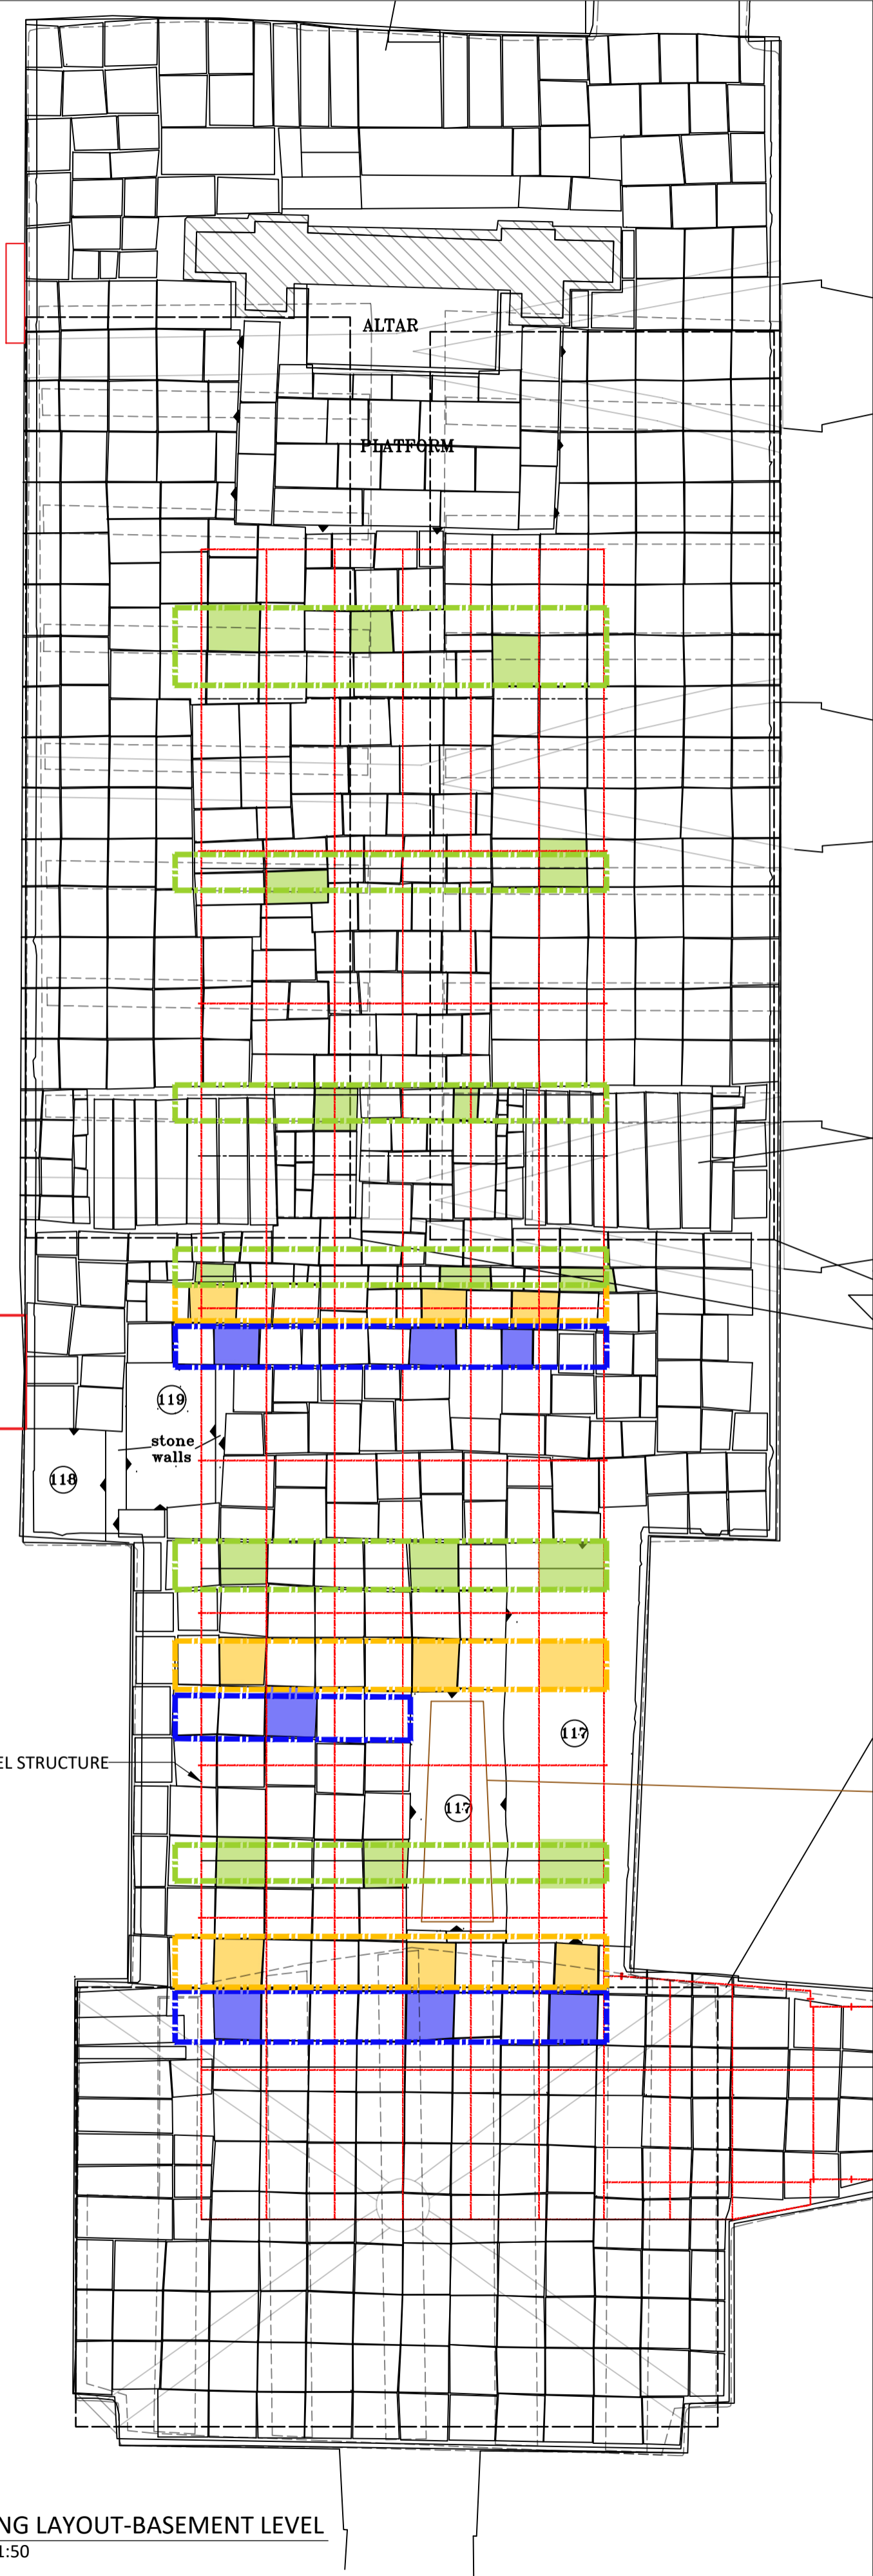
PAVING LAYOUT-BASEMENT LEVEL
SCALE 1:50

In Phase 01(refer to the attached plan), it is being proposed to carefully remove the marked stone slabs 'cangatura' and any underlying buildup using handheld methods to potentially expose the underlying rock/wall substrate. Should no rock/walls be exposed, further stone slabs 'cangatura' will need to be removed as highlighted in Phase 02 and Phase 03. All the removed stone slabs 'cangatura' will be mapped, numbered and stored temporarily on site together with any removed bedding material to be reinstated in their original positions once all investigative and/or stabilisation works are completed.

Based upon the findings recorded in Phase 01 or Phase 02 or Phase 03, it is being proposed to carefully remove an entire row of stone slabs ‘cangatura’ using handheld methods to expose the area where a suitable substrate has been exposed in Phase 01, Phase 02 or Phase 03. Once more, all removed stone slabs ‘cangatura’ will be mapped, numbered and stored temporarily on site together with any removed bedding material to be reinstated in their original positions once all investigative and/or stabilisation works are completed.
